RE: Administrative Compliance Order and Information Request Response
Weitsman Shredding, LLC
Town of Owego, Tioga County, New York
CWA-02-2019-3046
NPDES Tracking No. NYR00D022
Project No. 2012069

TABLE 1 - PROPOSED ACTIONS AND SCHEDULE

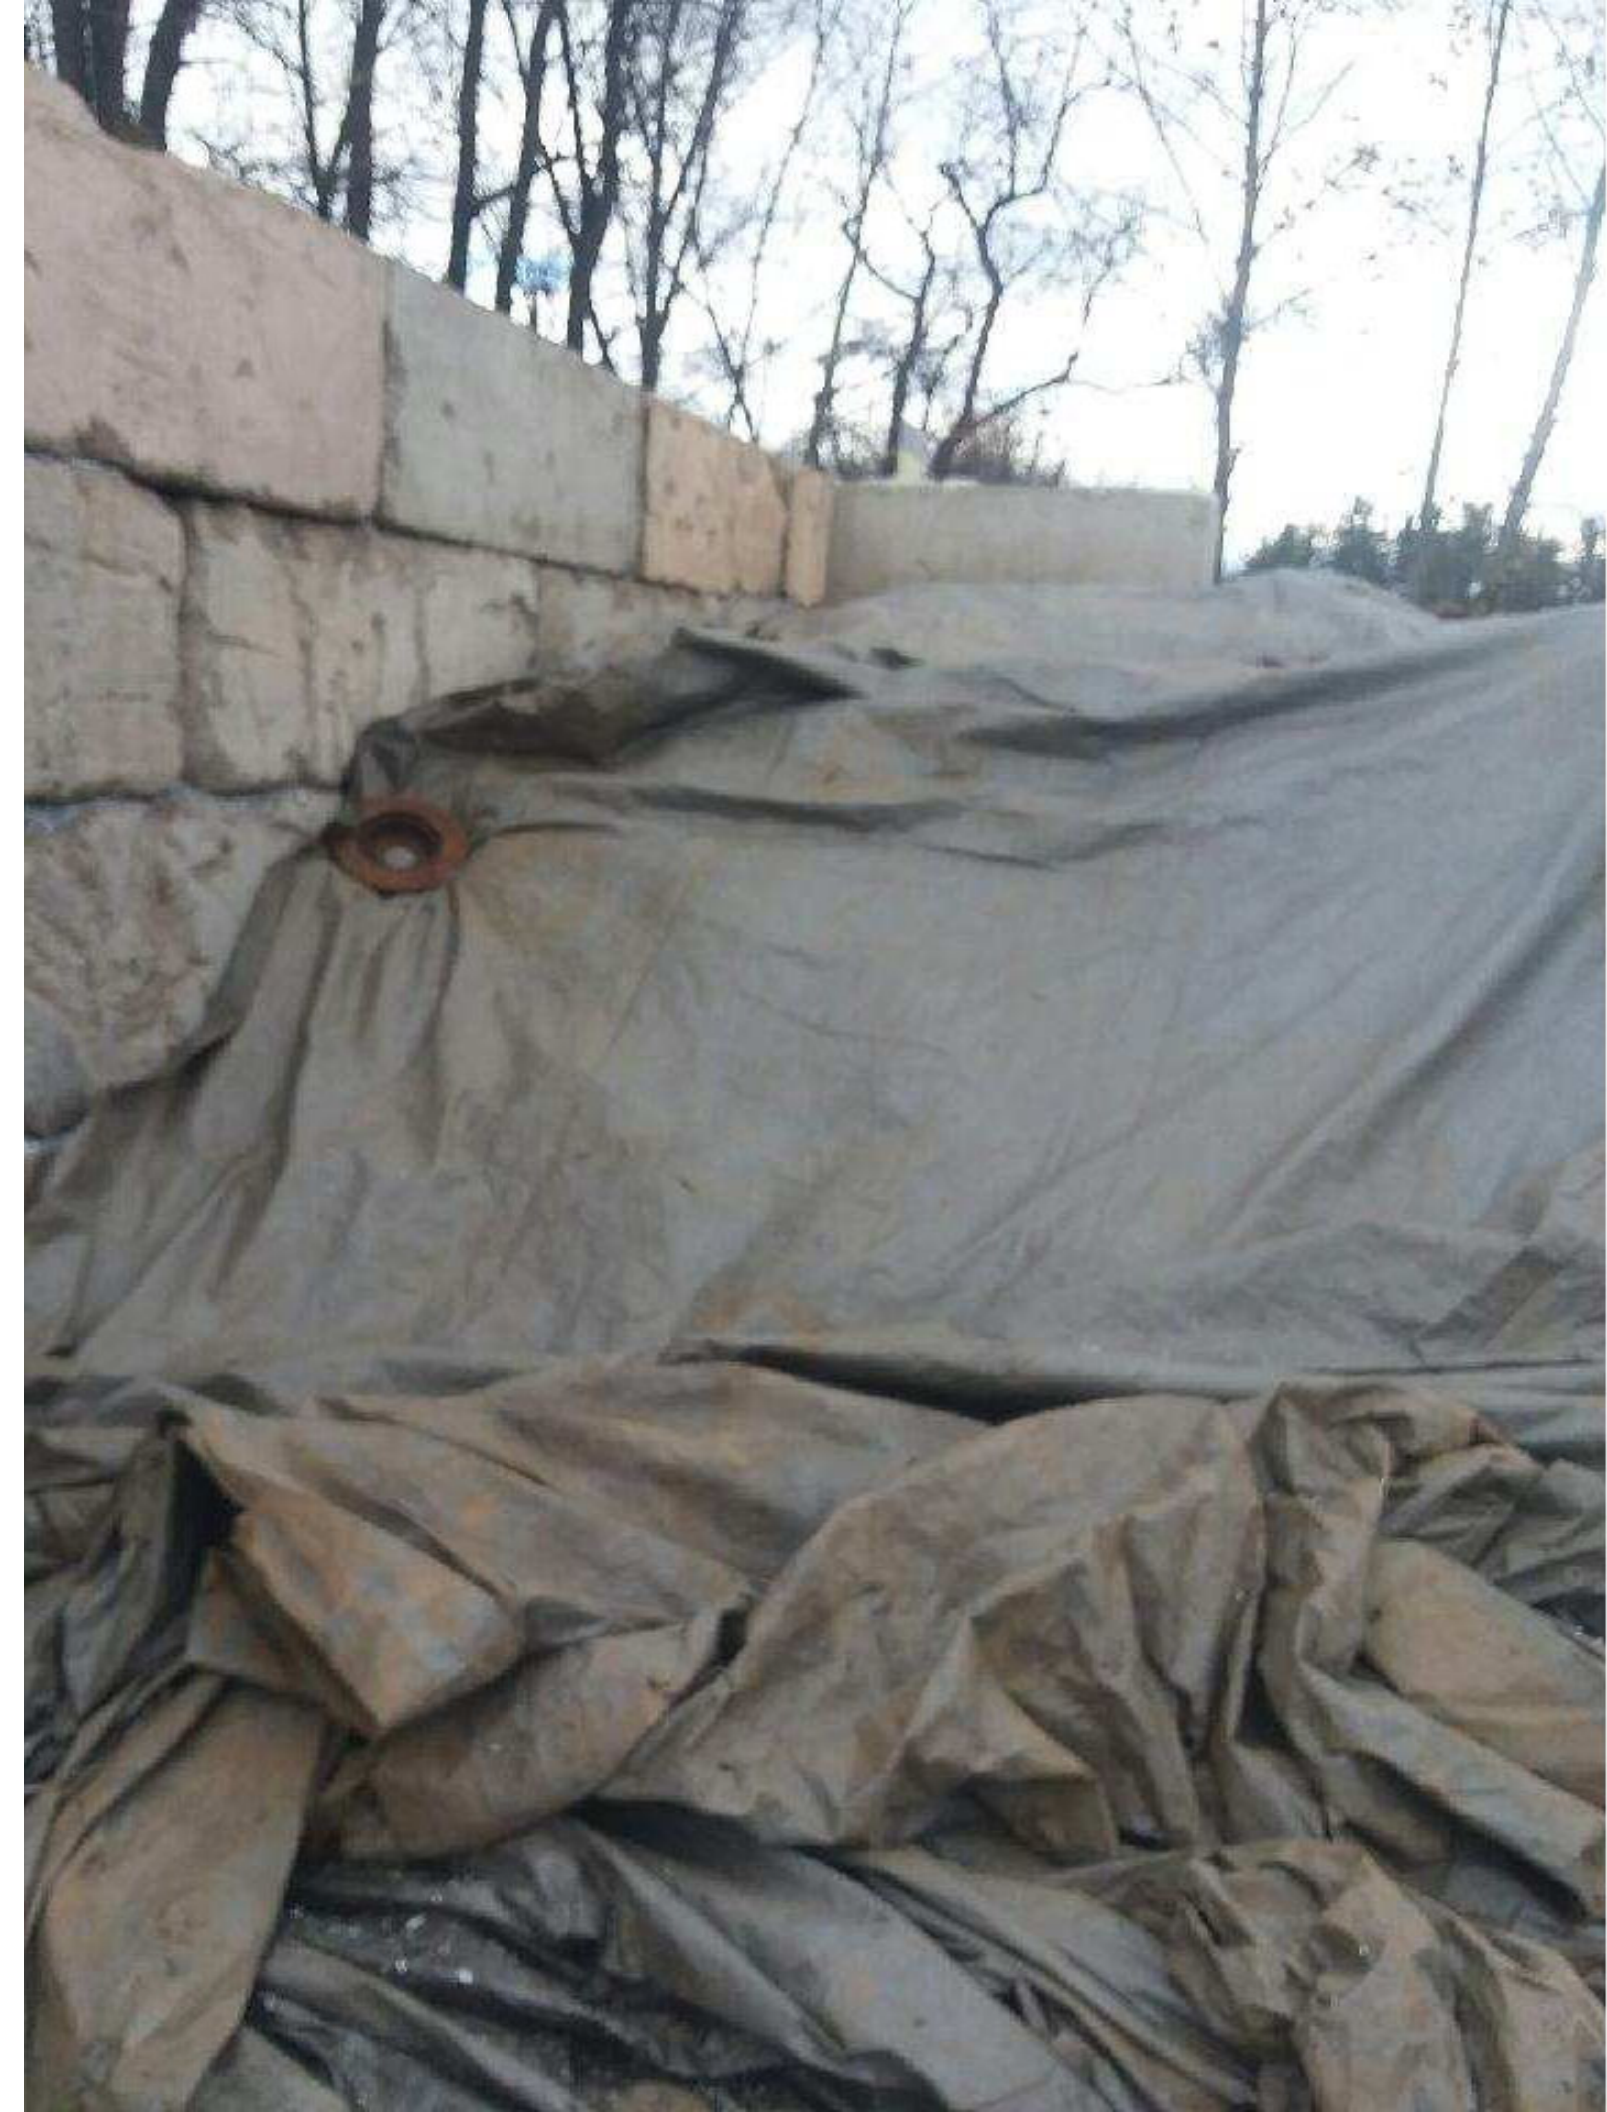
A photograph of a construction site. In the foreground, a large, rough-textured concrete wall is visible. A white rectangular sign with a black border is attached to the wall. The sign contains the text "ALL TURNINGS MUST BE TARPED AT ALL TIMES" in blue, all-caps, sans-serif font. To the left of the wall, a large pile of material is covered with a grey tarp. In the background, there are bare trees and a cloudy sky.

ALL
TURNINGS
MUST BE
TARPED AT
ALL TIMES

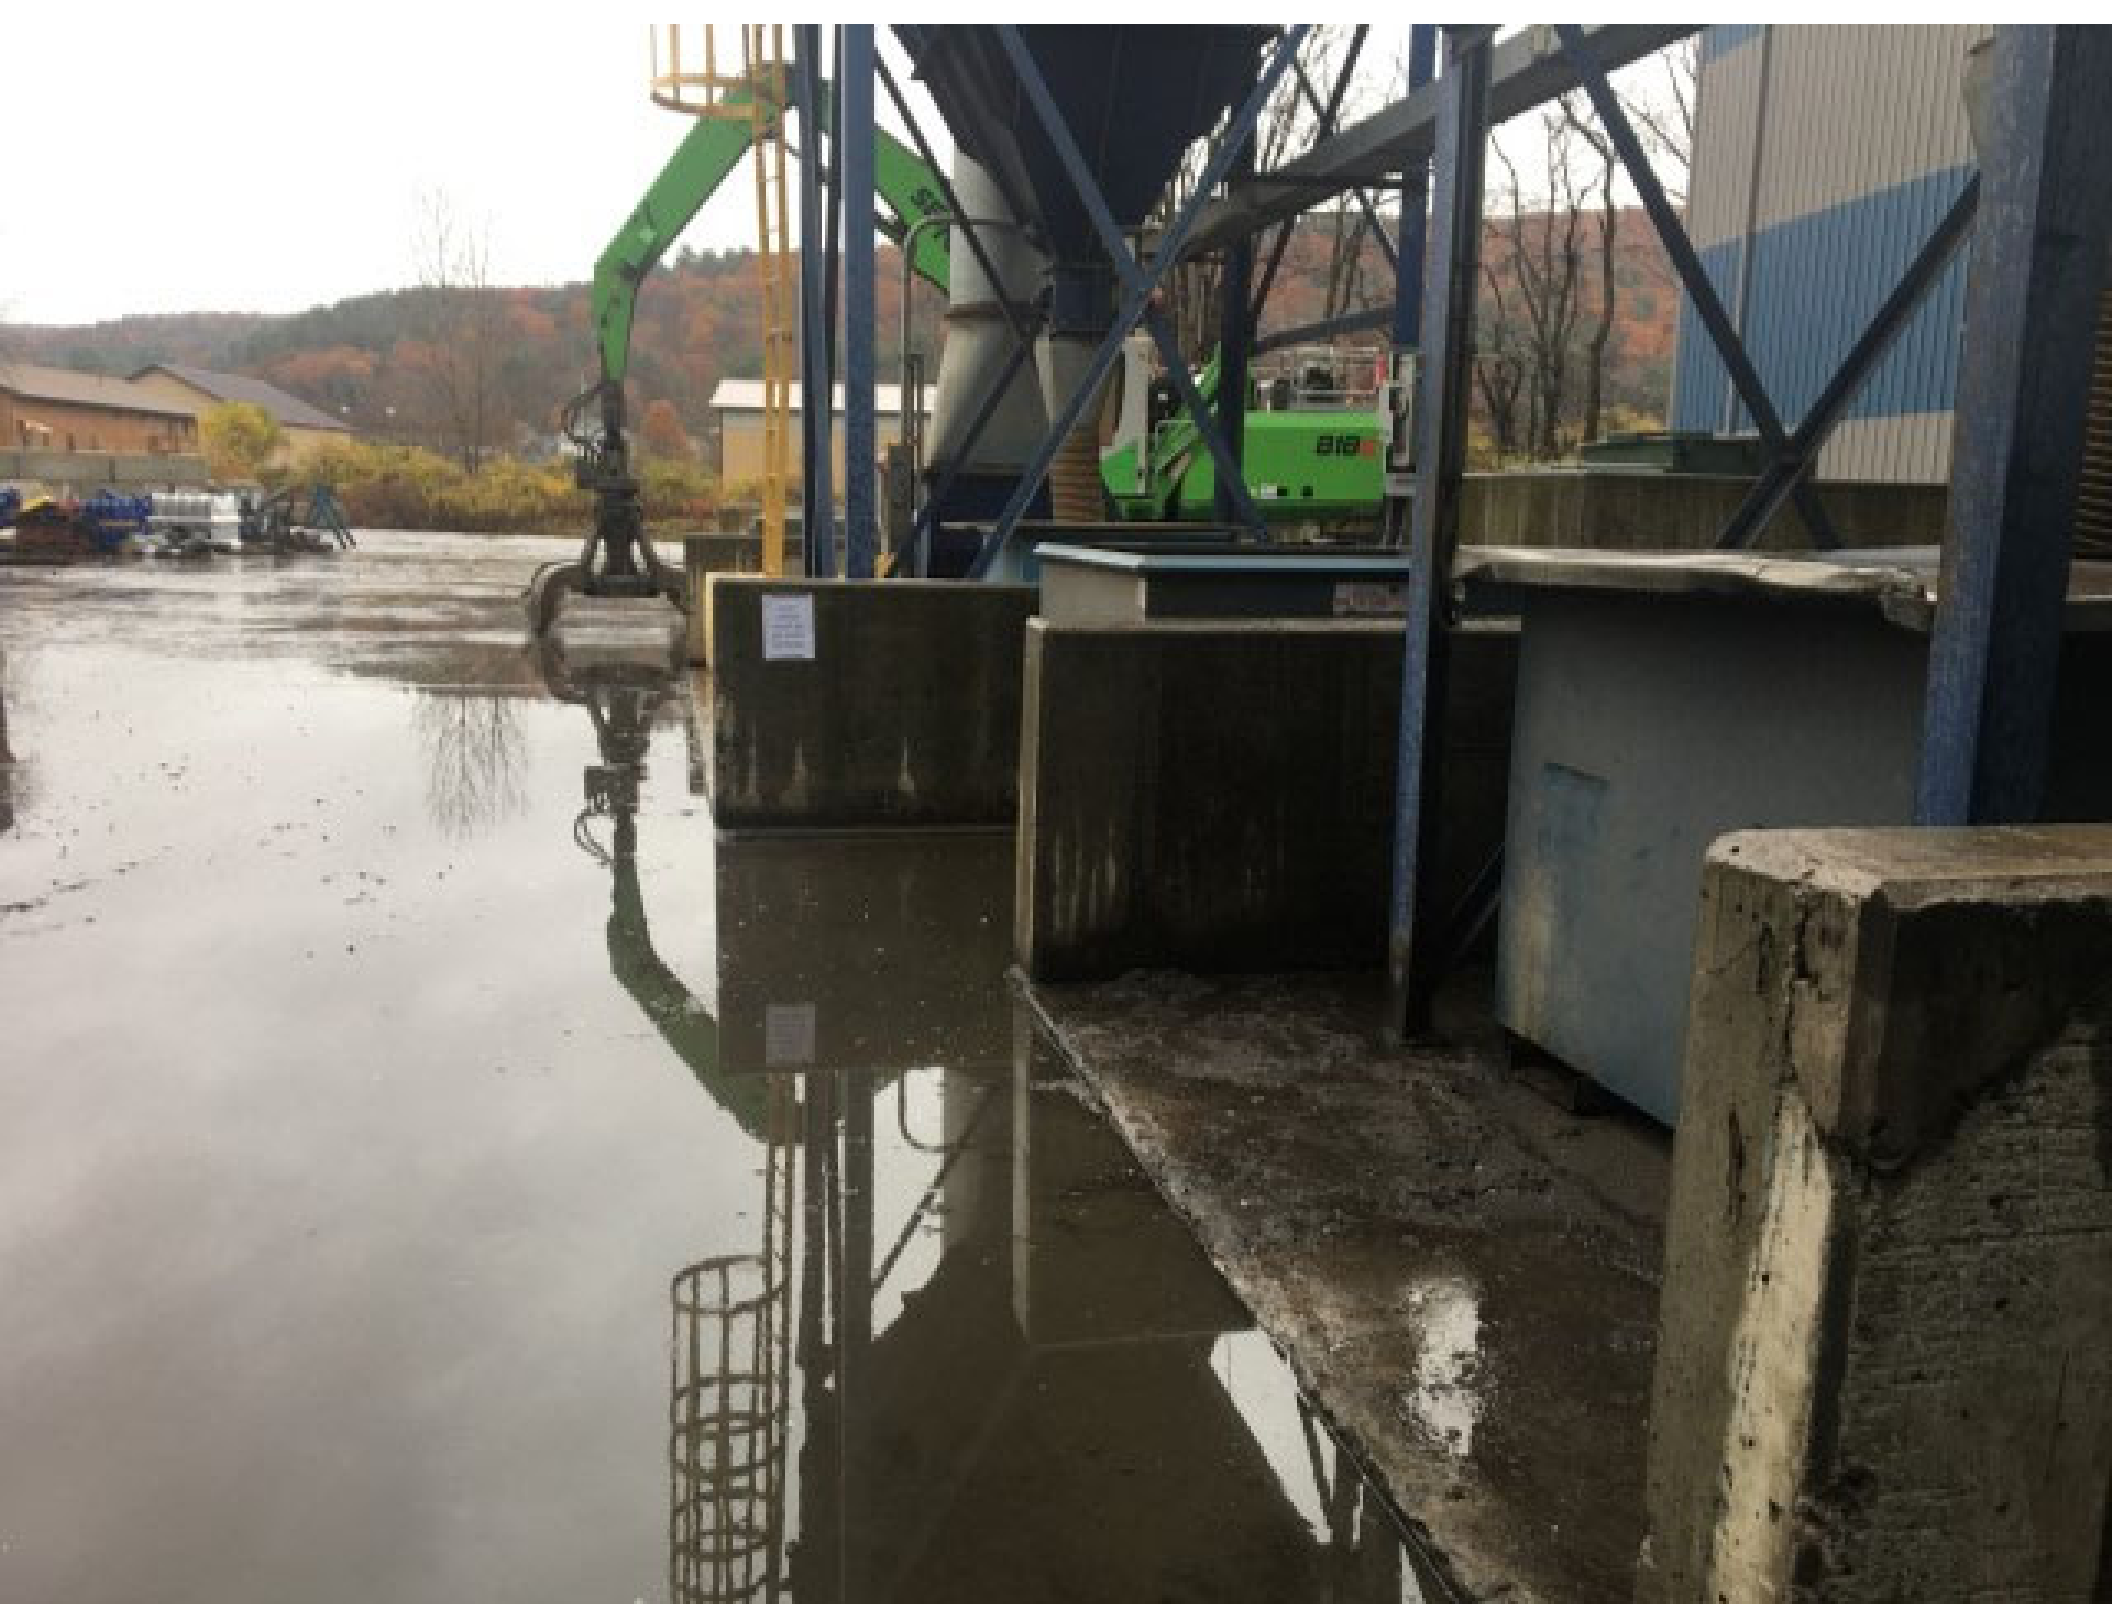
DUST
COVER
MUST BE
ON WHEN
RUNNING

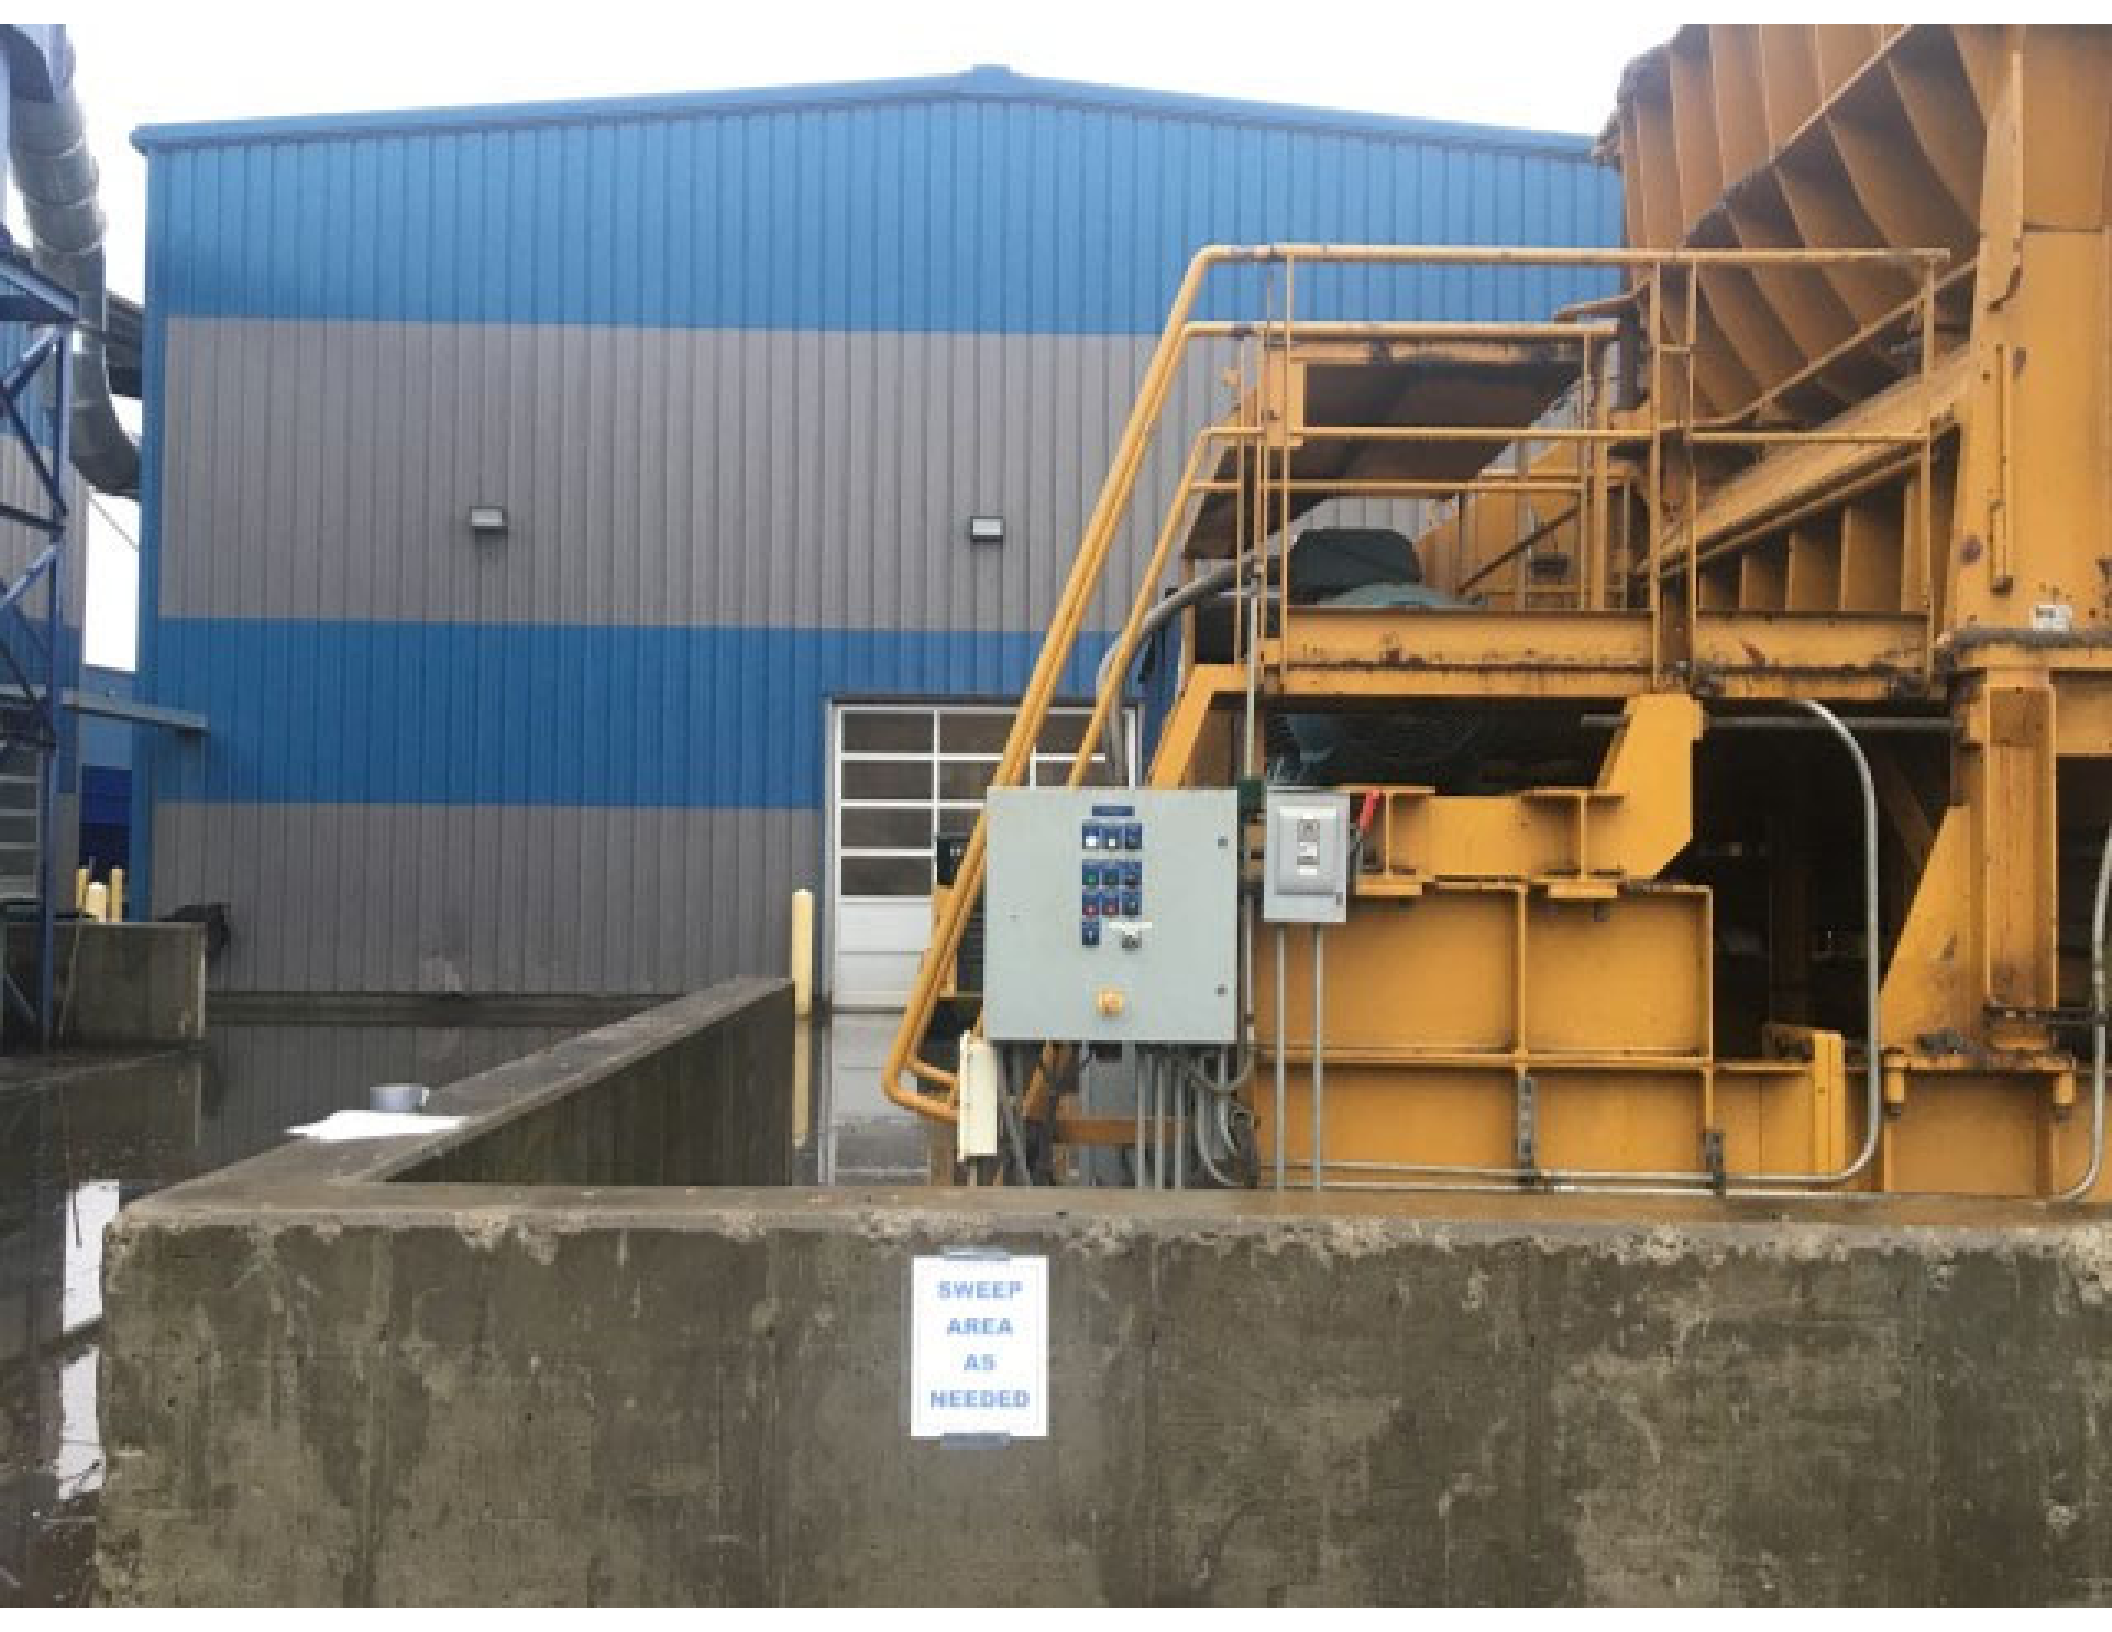
SWEEP
AREA
AS
NEEDED
